AFML-TR-76-50

Plastic
DEVELOPMENT OF LARGE SCALE EXTRUSIONS

AMOCO CHEMICALS CORPORATION
SEYMOUR INDIANA

FINAL REPORT

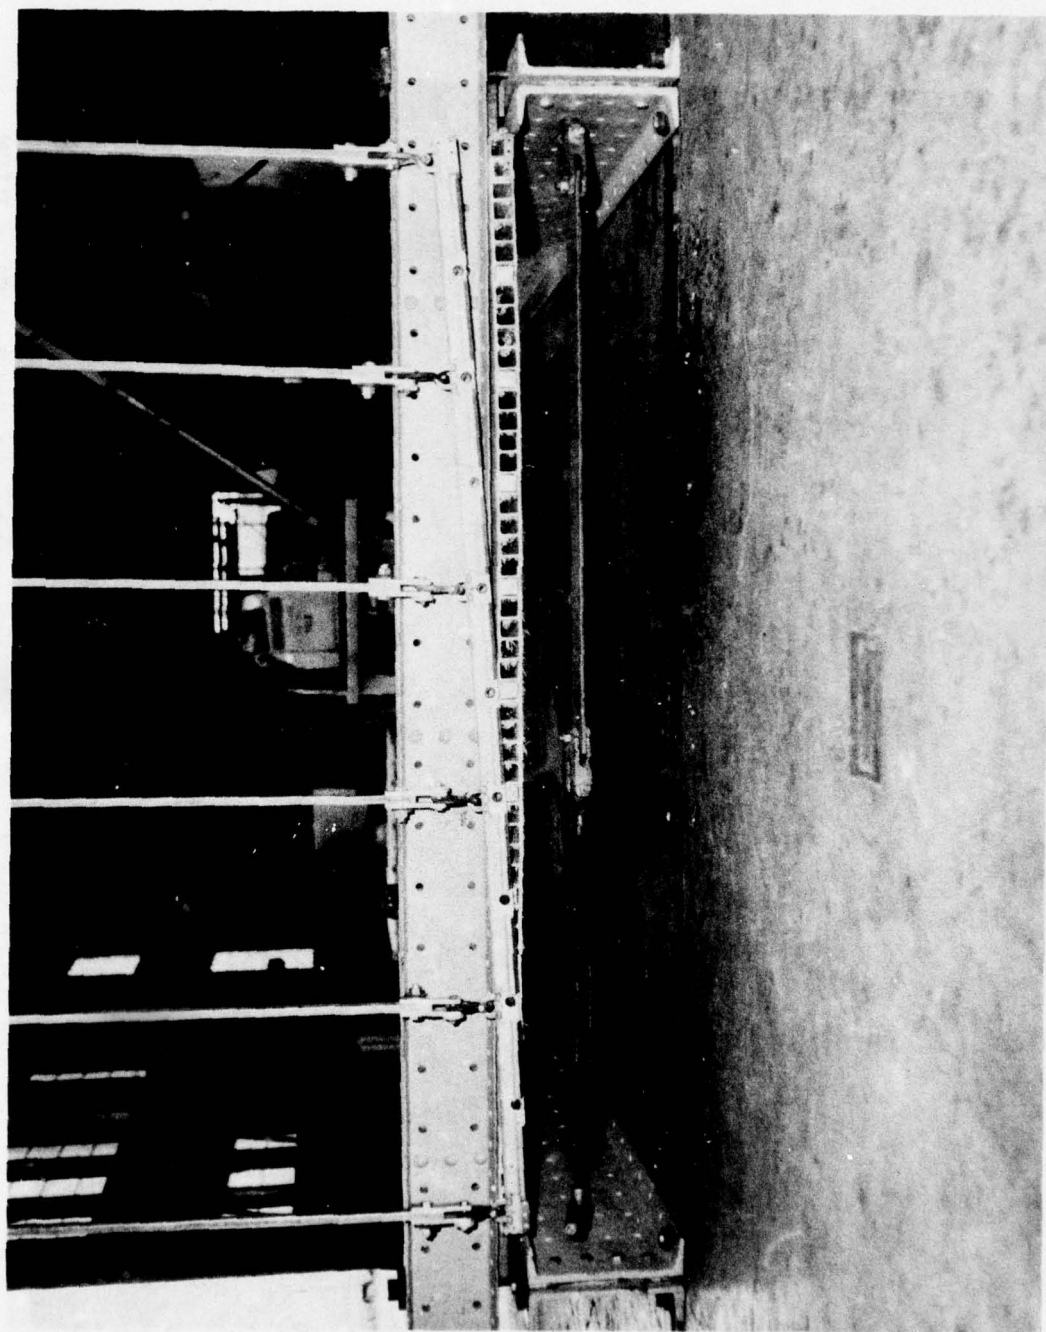
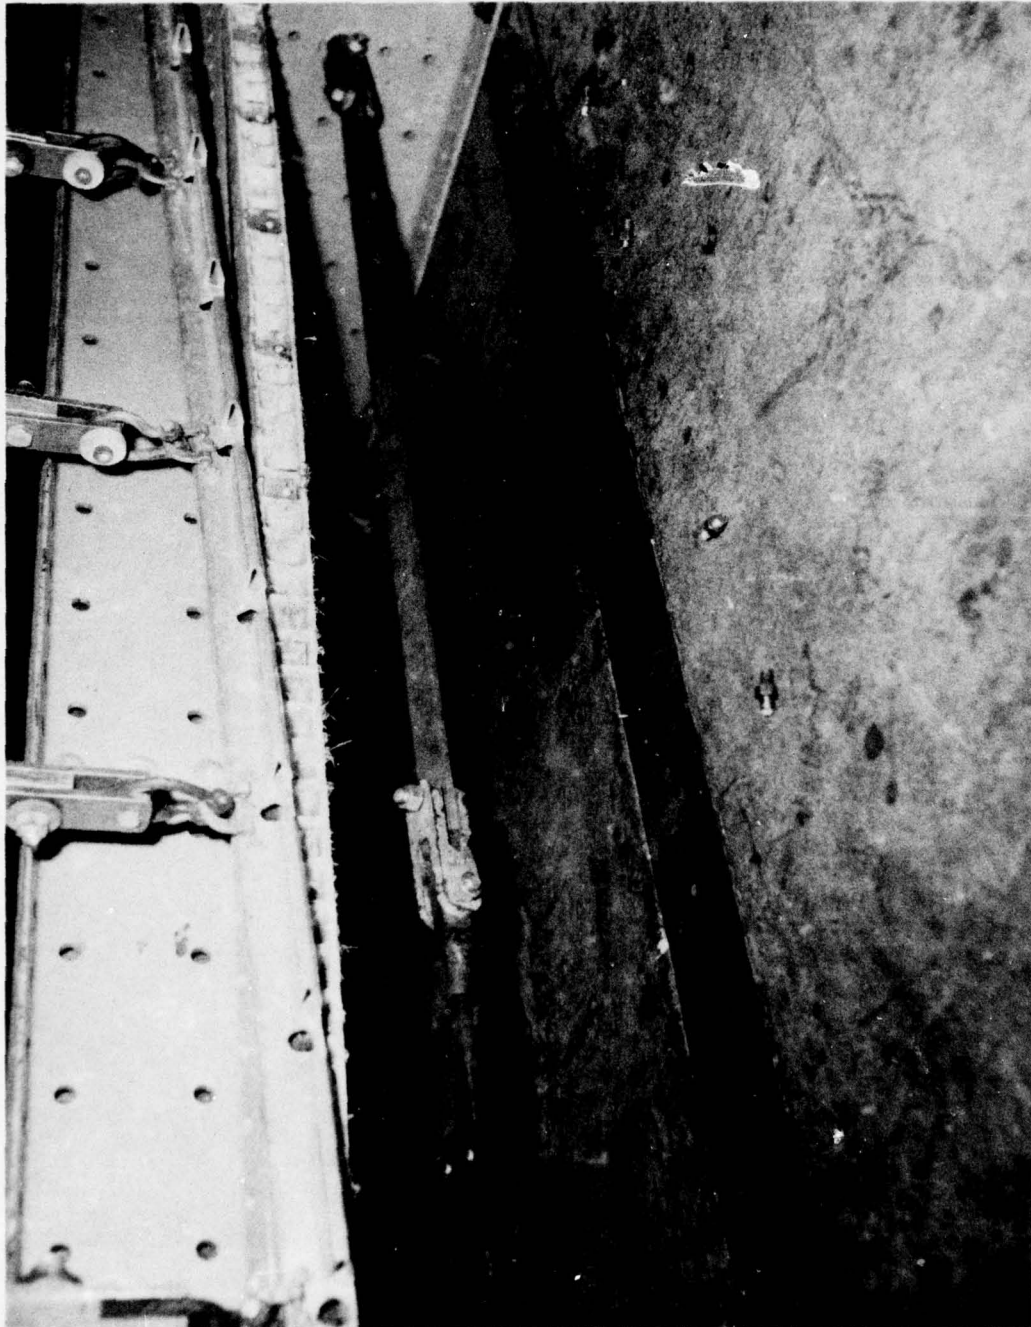
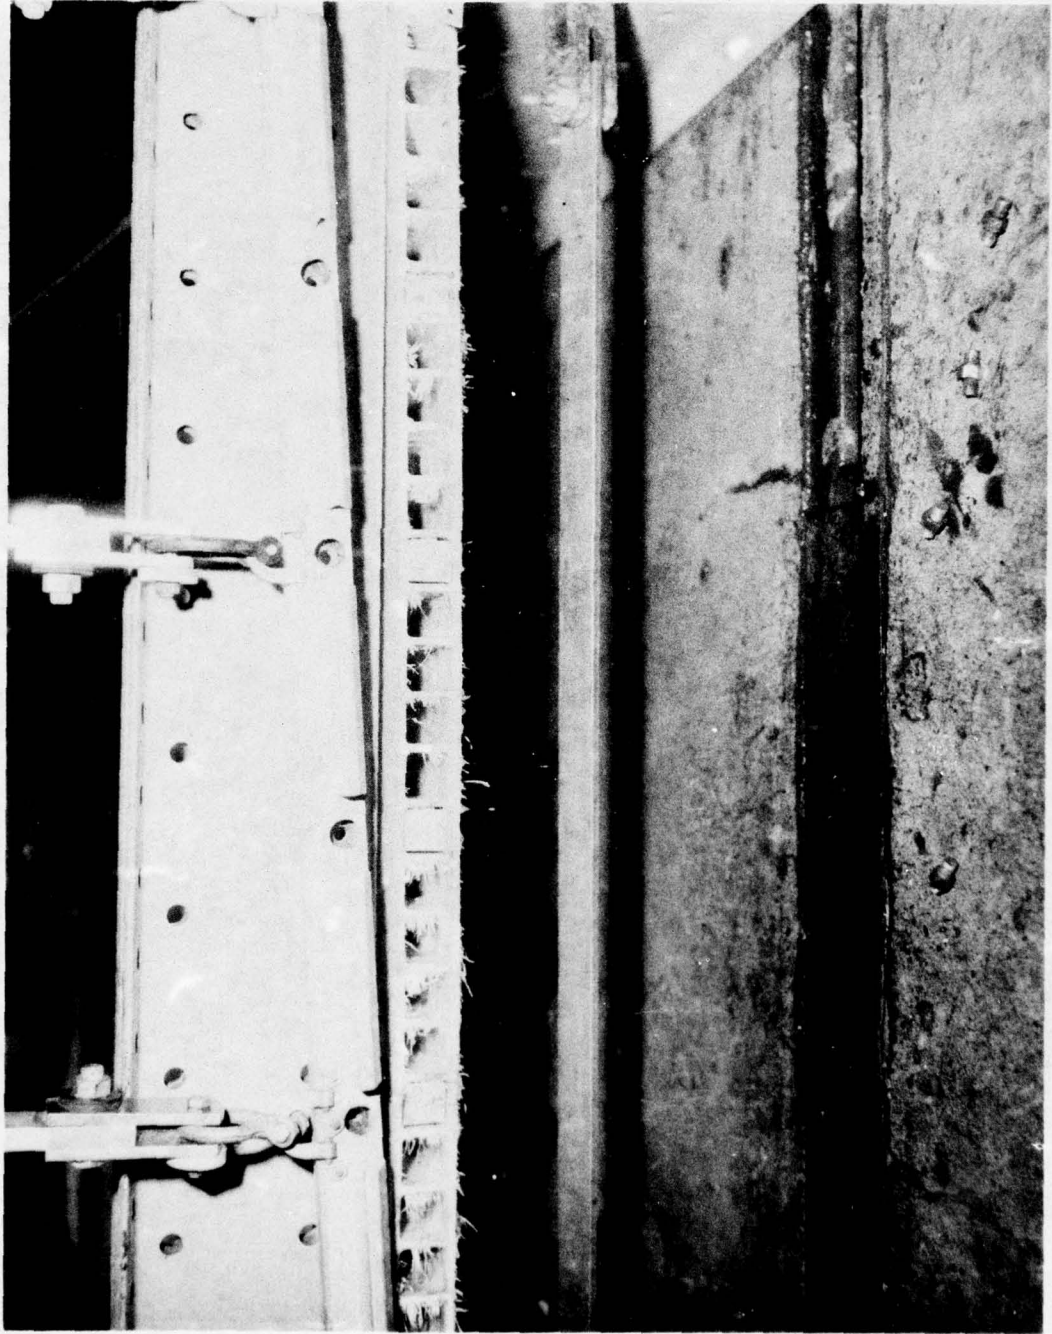
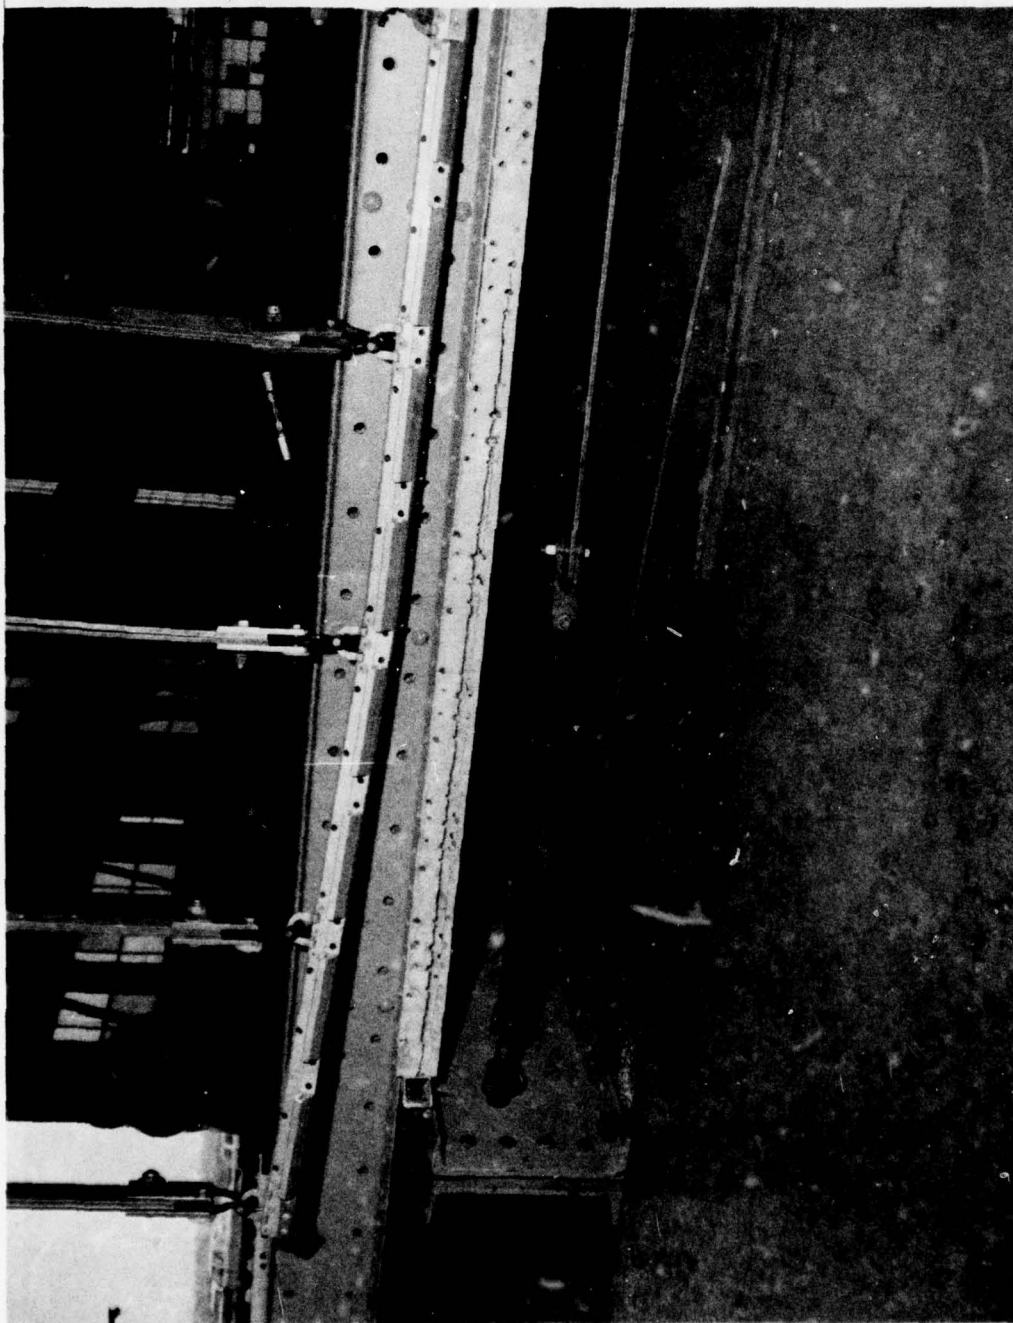
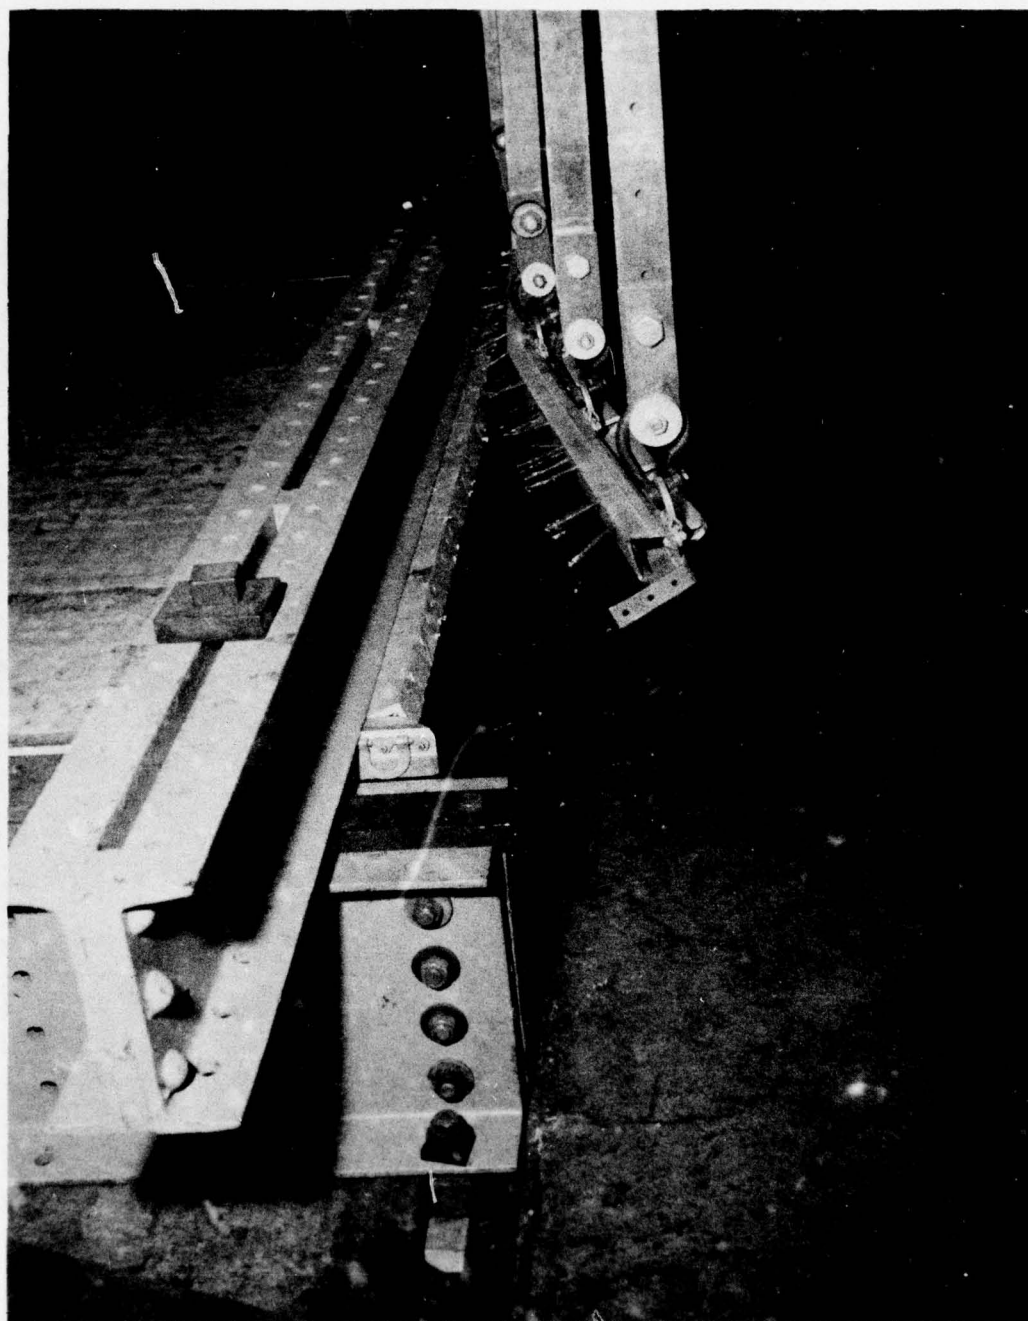
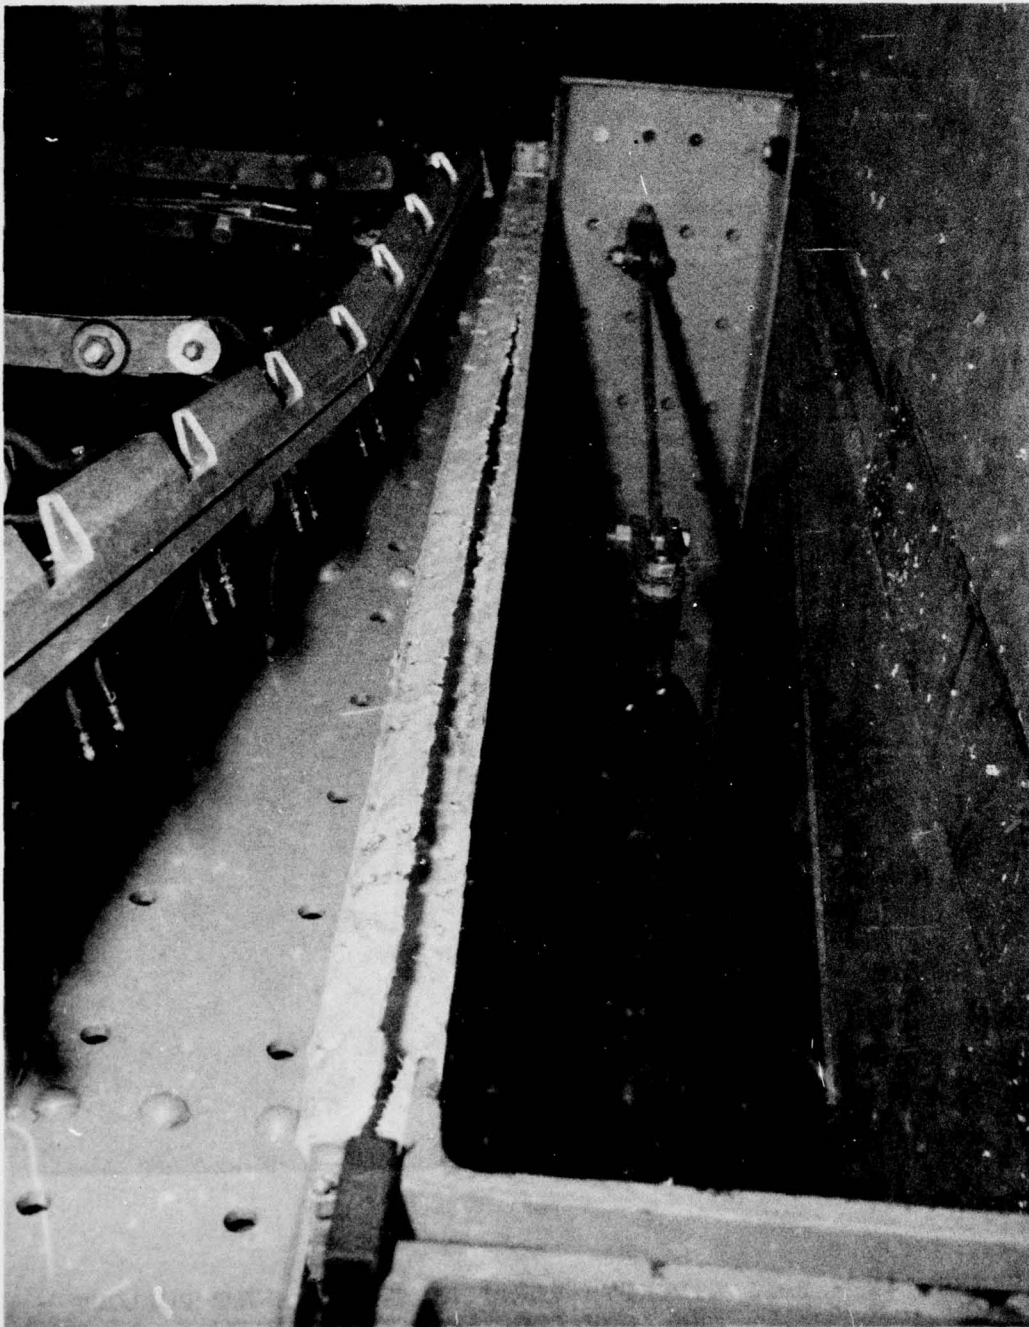
(4) As shown in Figures 45, 46, and 47, the failure along the 108-inch side resulted primarily from the aluminum rods failing in shear. Again the steel bolts pulled through the aluminum plate along the 88-inch side Figures 48, 49 and 50.

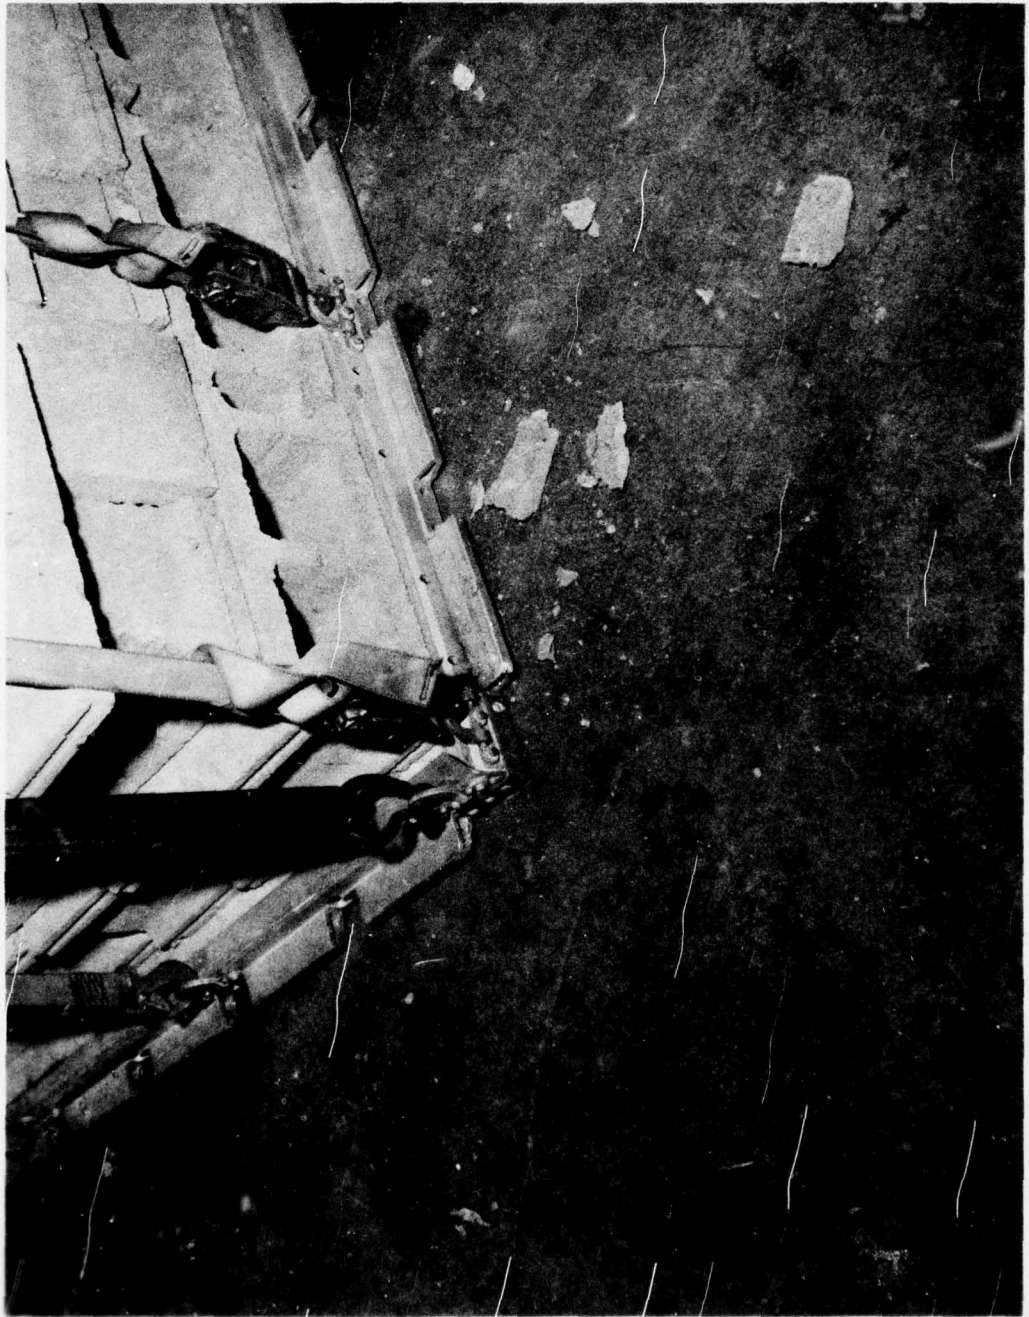
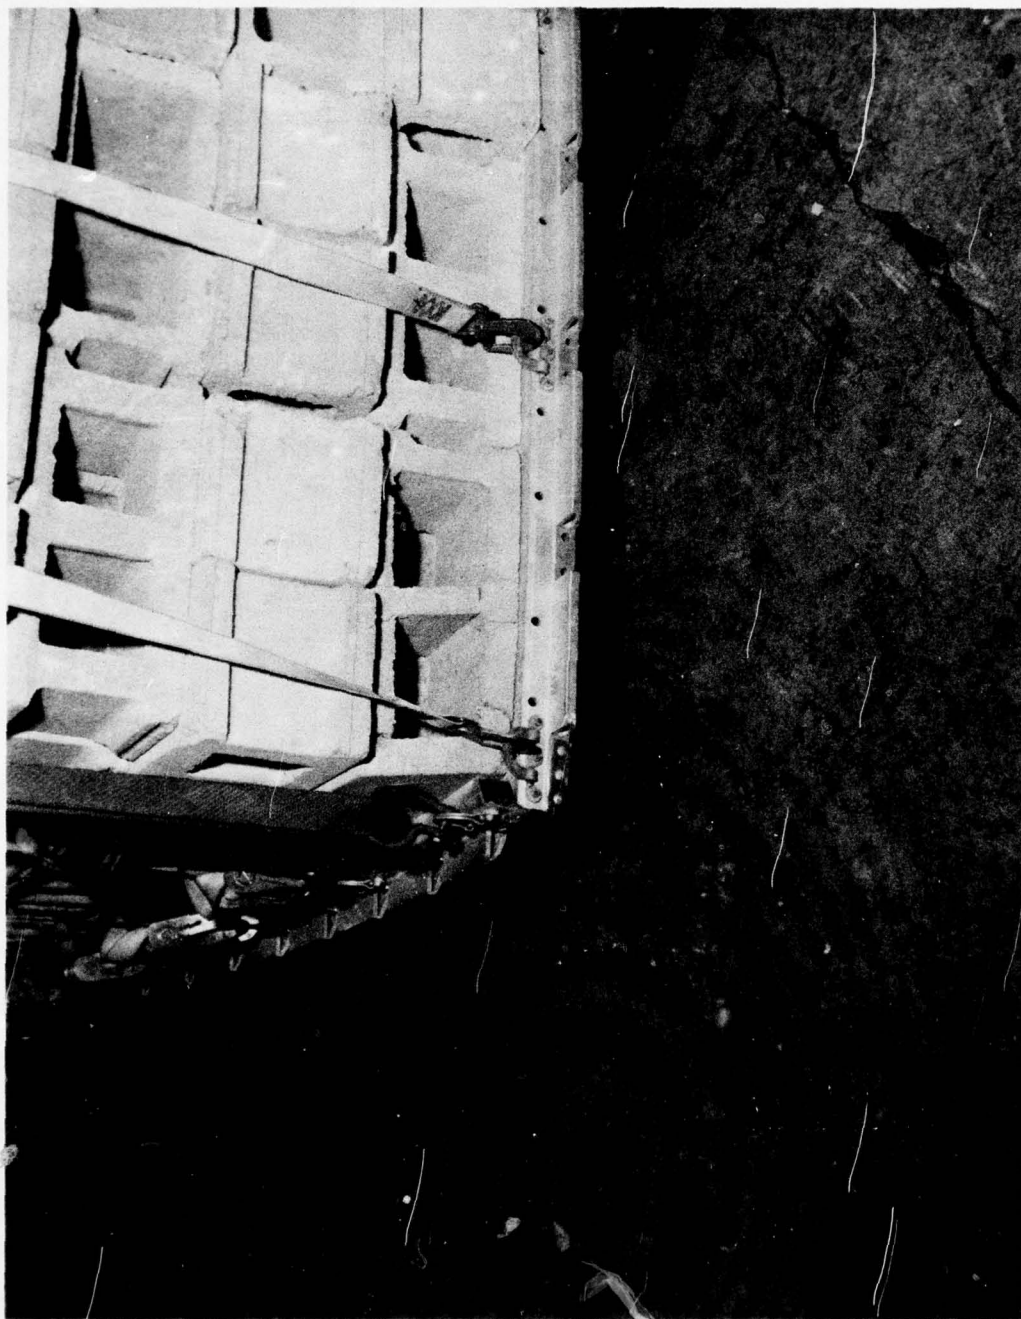
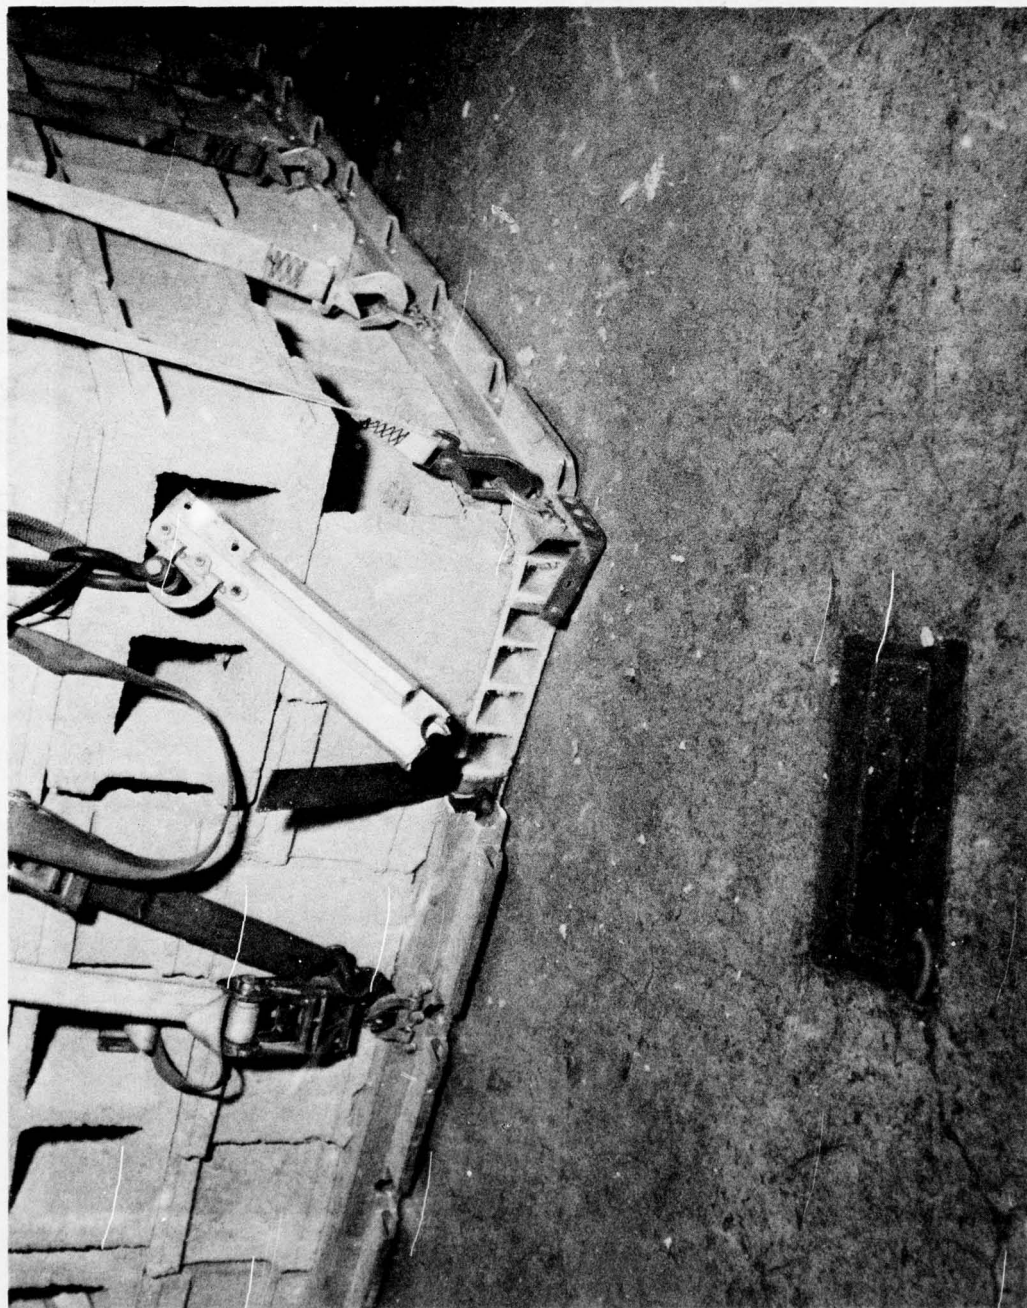
(2) Several rivets from different corners, Figure 53, failed in shear after the second lift. Rail separation, Figure 54, was noted after five on the eighth lift, the pallet side rail failed at one corner. This failure was diagnosed as being a direct result of rivet failures at the mitered corner, Figure 55.

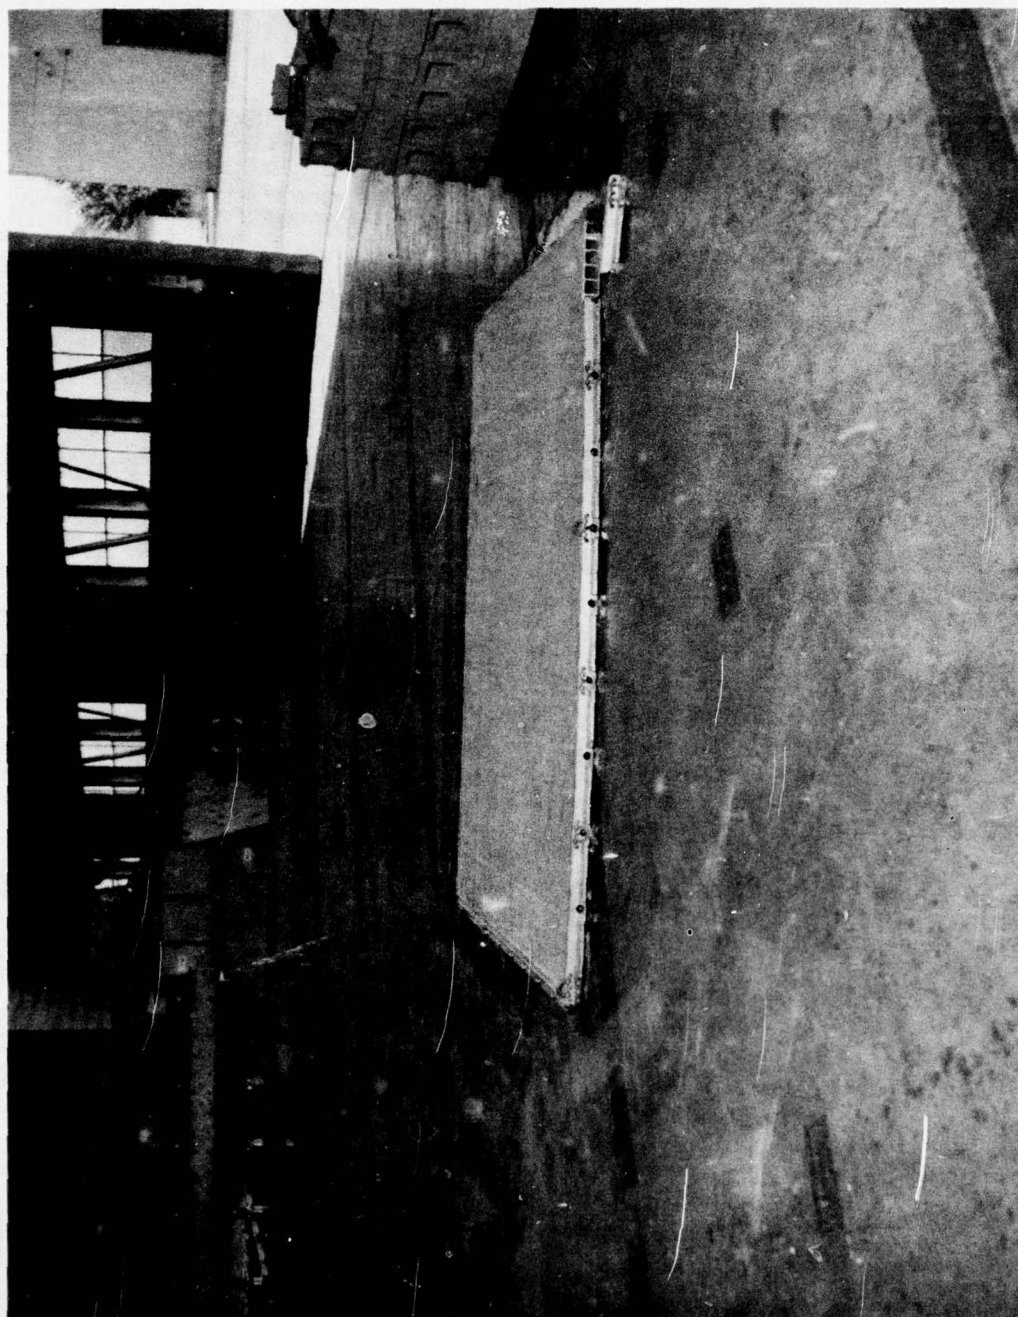
FIGURE 56 - PALLET AFTER SLING LOAD TEST

(3) Permanent deformation of the polymer section was not noted after the pallet was unloaded. This may not indicate an acceptable condition because the 18,000 pound load probably flattened the pallet when it was repositioned on the flat floor, Figure 56.
